R. G. STRUBLE DAM

PHASE I INSPECTION REPORT NATIONAL DAM INSPECTION PROGRAM

Name of Dam: Robert G. Struble Dam

Name of Dam: Robert G. Struble Dam ID # PA 00621
State Located: Pennsylvania
County Located: Chester County
Stream: East Branch Brandywine Creek
Coordinates: Latitude 40° 6.7' Longitude 75° 51.9'
Date of Inspection: May 2, 1979

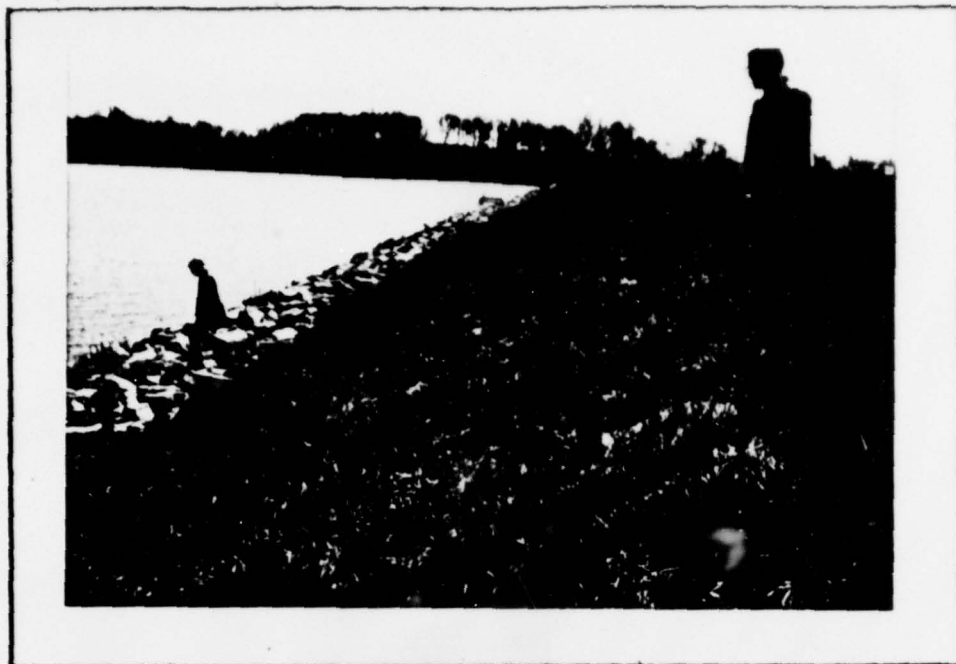
- a. Visual Observations. The downstream face of the embankment and the visible portion of the upstream face appear to be in good condition. There are no visible signs of instability of the dam. The survey of the top of dam revealed that little settlement has occurred since construction. The entire length of the top of dam is well above design elevation which is evidence of the overfill built into the top of the dam for possible future settlement of the embankment and to maintain a level appearance.

*UPSTREAM FACE OF THE DAM
LOOKING TOWARDS THE LEFT ABUTMENT*

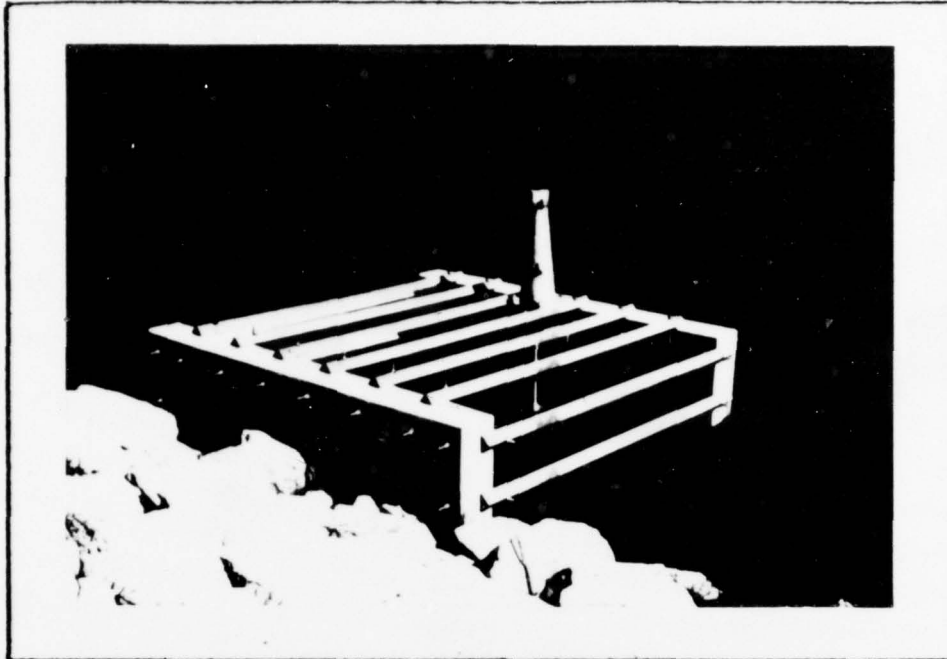
THE INTAKE STRUCTURE (RISER) APPEARED
TO BE IN GOOD CONDITION AND WAS
UNOBSTRUCTED.

*PRINCIPAL SPILLWAY RISER INLET STRUCTURE
ADJACENT TO THE ROCK BERM ON THE
UPSTREAM FACE OF THE DAM*

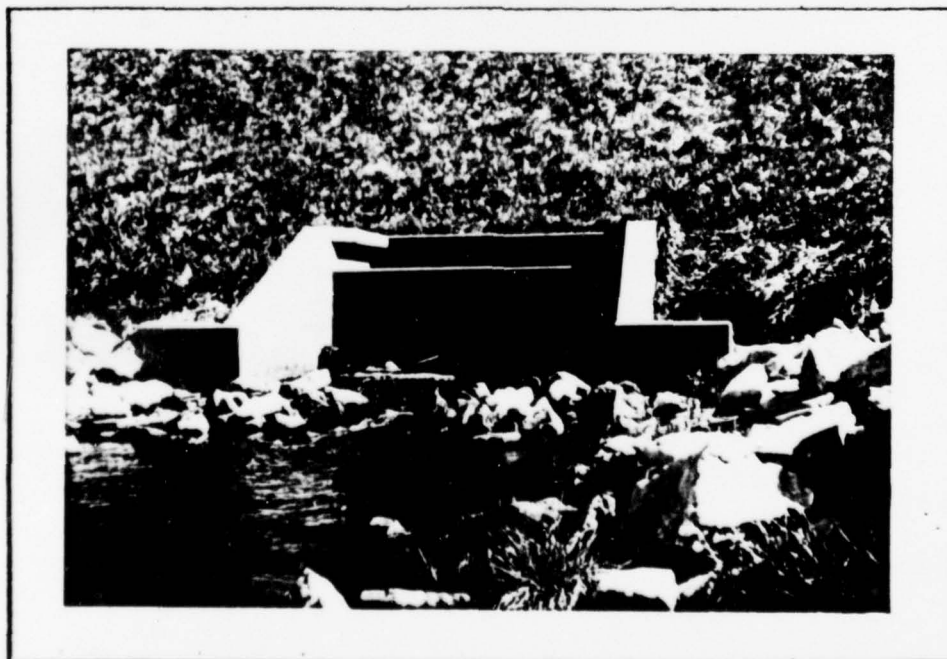
The principal spillway appears to be in good condition and is apparently functioning properly. During the inspection, a small amount of water was flowing from the toe drain outlets, which are located in the impact basin side walls. The discharge was slightly greater from the left side toe drain.

THE IMPACT PADDY ALSO APPEARED TO
BE IN GOOD CONDITION AND
WAS FUNCTIONING PROPERLY.

*PRINCIPAL SPILLWAY IMPACT BASIN OUTLET
STRUCTURE AT THE DOWNSTREAM TOE OF THE DAM*
